Virginia Home Inspection Service

Inspected Property
1251 Jessees Mill Road
Lebanon, VA 24224

Inspection Date
Saturday, October 16, 2004

Report ID:
1002

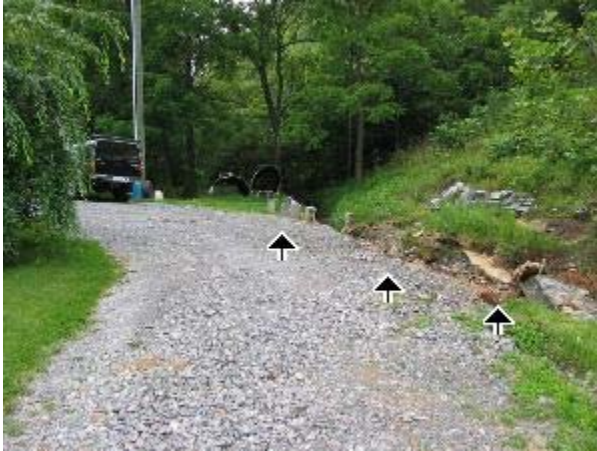
1.9 WALKWAY AND DRIVEWAY

Comments: Inspected, Maintenance Repair/Replace
Gravel drive at right side of home (facing front) needs repair work at erosion areas and gravel or Road Bond placed.

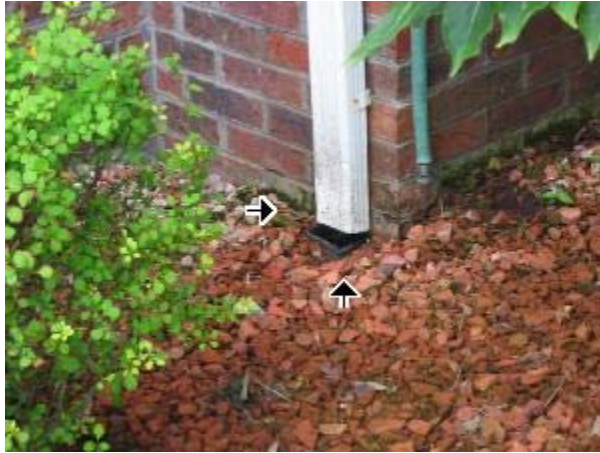
2.5 GUTTER DOWNSPOUTS AND DRAINAGE

Comments: Maintenance Repair/Replace
Ground drain-line has settled and pulled loose from downspout on front right corner of home.
Needs re-connecting.

Ground drain-line has settled and pulled loose from downspout on front right corner of home. Needs re-connecting.

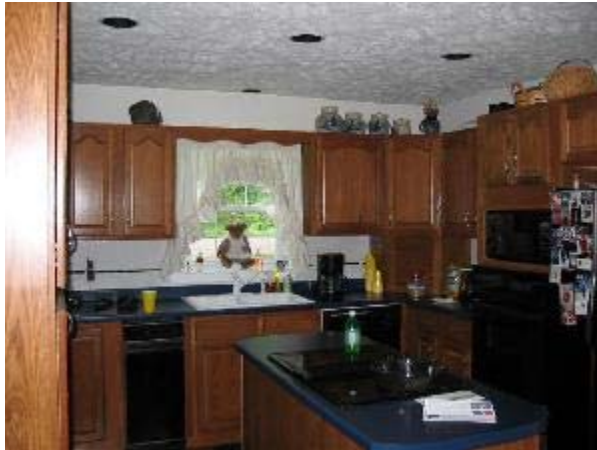
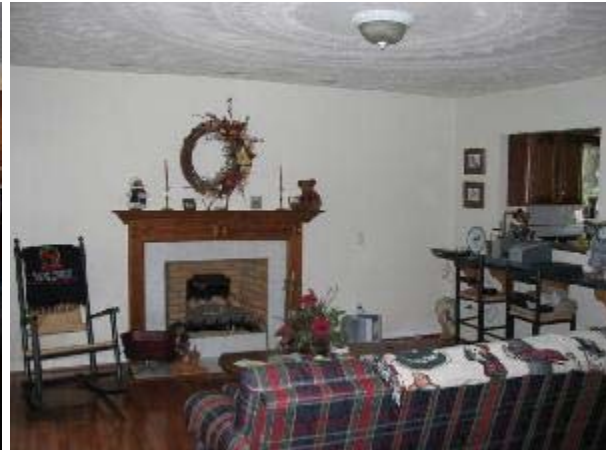
4.0 KITCHEN VIEW AT TIME OF INSPECTION

The picture of the Kitchen represents the view at time of inspection.

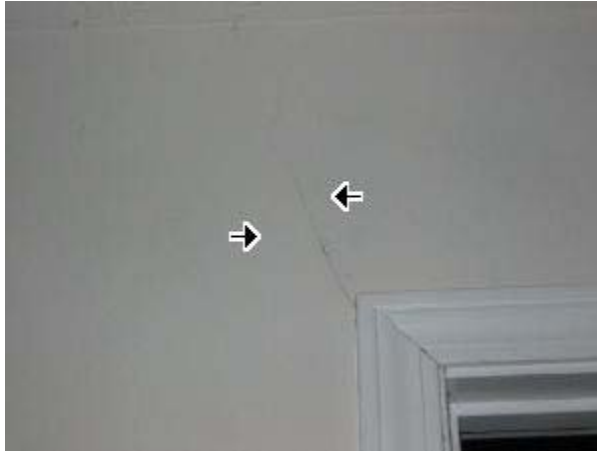
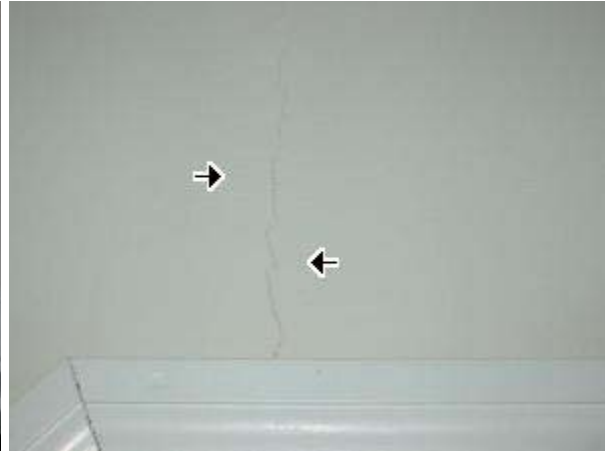
6.2 WALLS

Sheetrock on wall has several hairline cracks (cosmetic), but should be repaired at Dining Room and Master Bedroom.

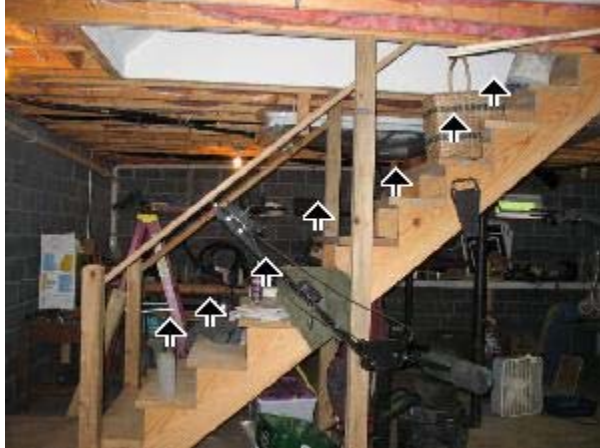
6.7 STEPS, STAIRWAYS, BALCONIES AND RAILINGS

Comments: Inspected, Maintenance Repair/Replace Hand/guard rail for stairs to basement needs proper picket spacing (4 inch max between pickets recommended).

Hand/guard rail for stairs to basement needs proper picket spacing (4 inch max between pickets recommended).

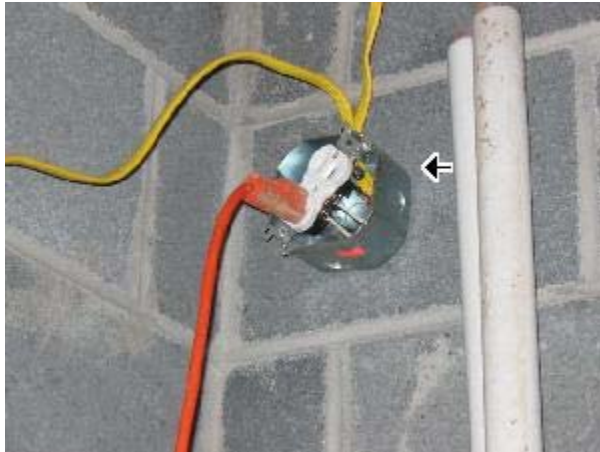
7.9 CONNECTED DEVICES, FIXTURES OR LOOSE WIRING (Observed from a representative number operation of ceiling fans, lighting fixtures, switches and receptacles located inside the house, garage, and on the dwelling's exterior walls)

One box needs a coverplate in basement. Recommend correct as necessary.

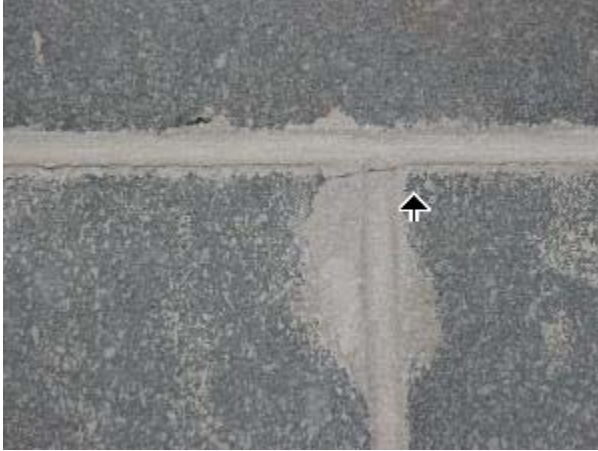
8.1 FOUNDATION WALLS AND MORTAR JOINTS

Horizontal crack in foundation wall in basement. This crack does not appear significant to require repairs at this time.

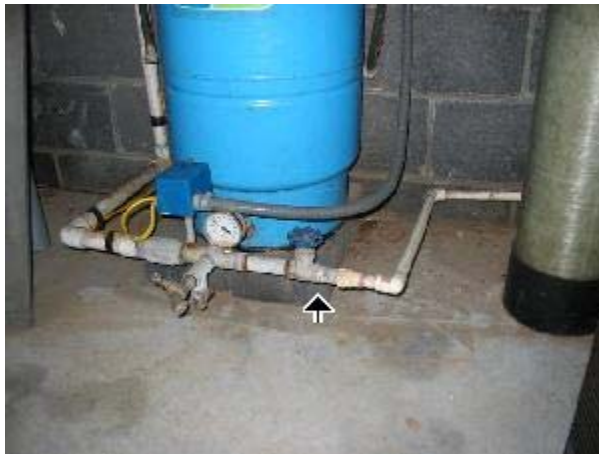
9.3 MAIN WATER SHUT-OFF VALVE (Describe location)

The main shut-off is located in basement at pressure tank.
